Manhole Inspection Summary

Manhole # S37GG_033MH

Location Address: **1300 HOMEWOOD AVE**

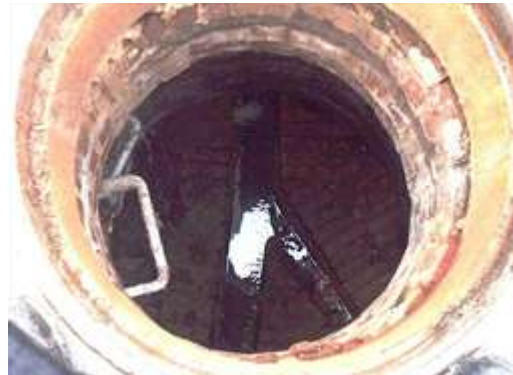
Top View

Infiltration: ☐ None ☐ Joint ☐ Cracks ☒ **Mortar** ☐ Roots ☒ **Wall**

☒ **Debris** (not Condition related)

Barrel infiltration. Bench and Channel debris.

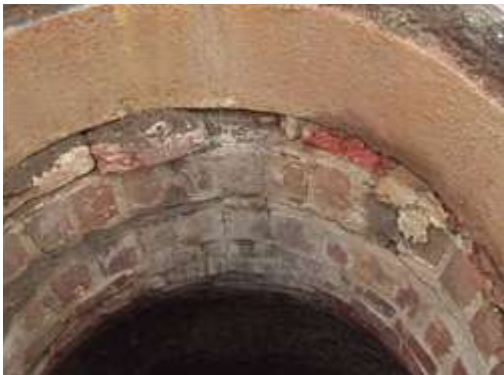
Defect

☒ **Leaks**

Condition: ☐ Sound ☐ Cracked ☐ Root Intrusion ☒ **Loose Brick** ☒ **Deteriorated**

Infiltration: ☐ None ☒ **Joint** ☐ Cracks ☒ **Mortar** ☐ Roots ☐ Wall

Frame leaks. Adjustment deterioration, loose brick and infiltration.

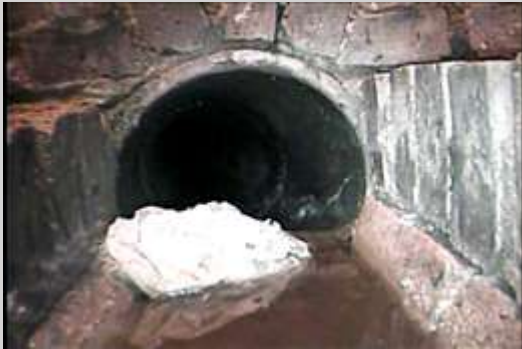
8 in. Circular Gravity Sewer Pipe Out @ 12 O'Clock

Channel deterioration.

Deposits: ☐ None ☐ Mud ☐ Sludge ☒ **Debris** ☐ Grease

Infiltration: **Evidence** Pipe Seal Cond: **Unknown**

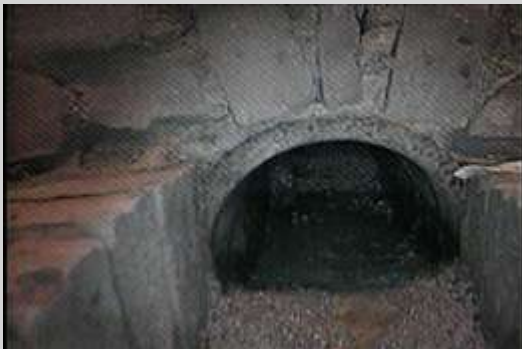
6 in. Circular Gravity Sewer Pipe In @ 4 O'Clock

Deposits: ☐ None ☒ **Mud** ☐ Sludge ☒ **Debris** ☐ Grease

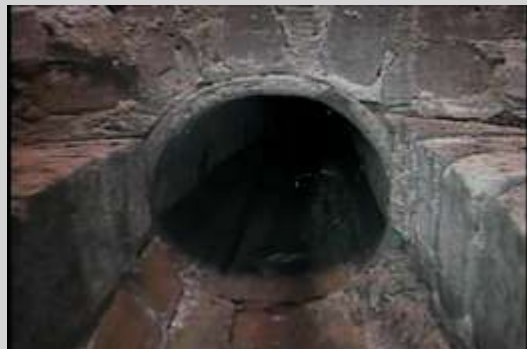
8 in. Circular Gravity Sewer

Deposits: ☐ None ☐ Mud ☐ Sludge ☐ Debris ☒ **Grease**
